2019 Outfall and Basin Inspection Report

Libertyville Township
Lake County, IL
December 2019

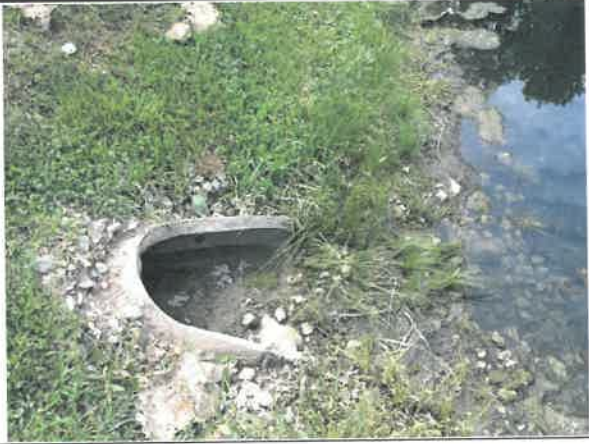
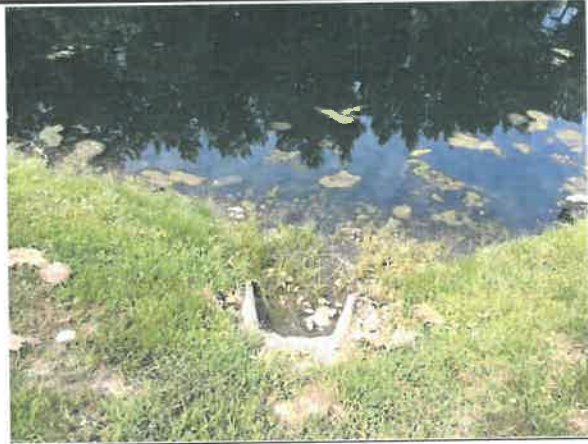
Additional comments:
Missing metal trash grate

Profile view of FES	Top view of FES

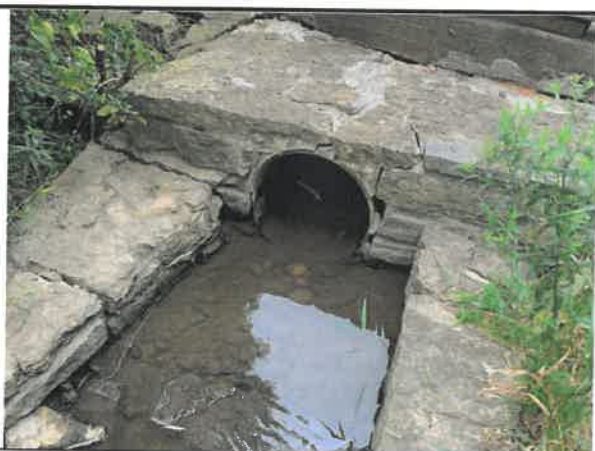
Outfall discharging into the basin. The outfall is in poor condition and sediment was observed in and outside of the outfall.

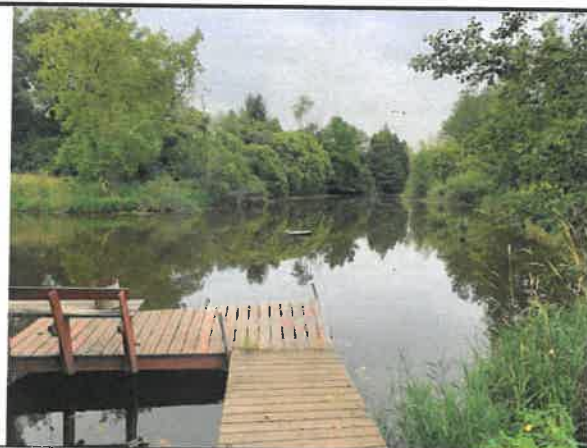
Overall view of the basin. Weeds present around the entirety of the basin. No other major issues observed.

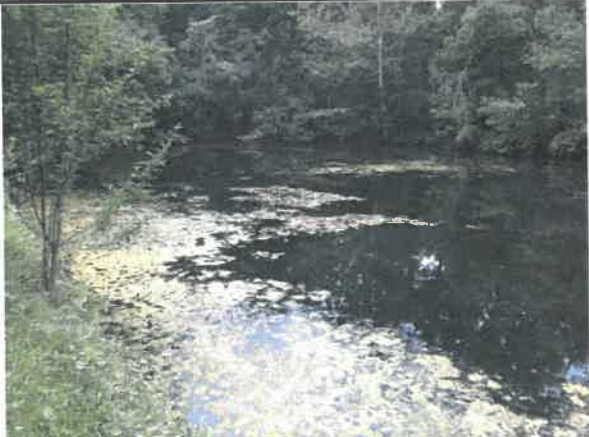
Sheen on surface of water	Northeastern side of basin looking south

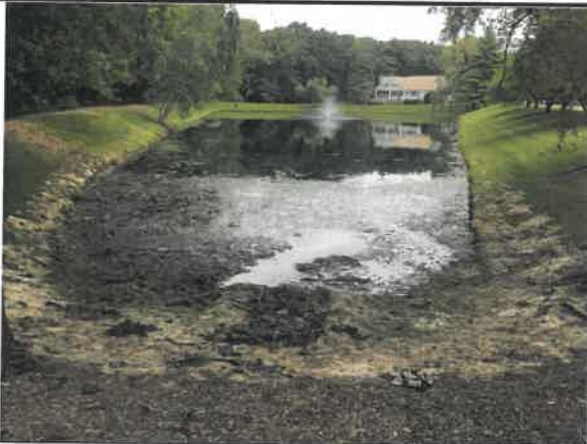
Accumulated sediment/ debris in storm inlet pipes on southerly side of basin
