2019 Outfall and Basin Inspection Report

Libertyville Township
Lake County, IL
December 2019

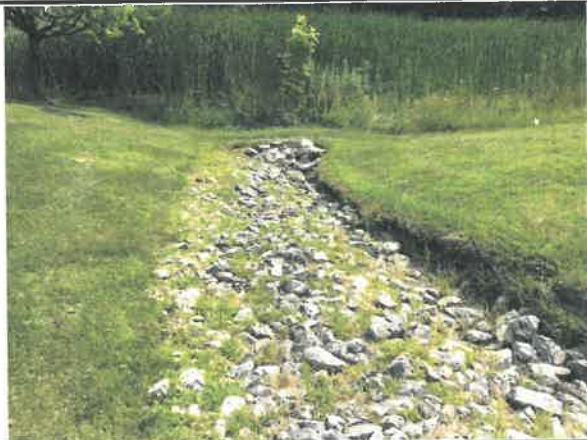
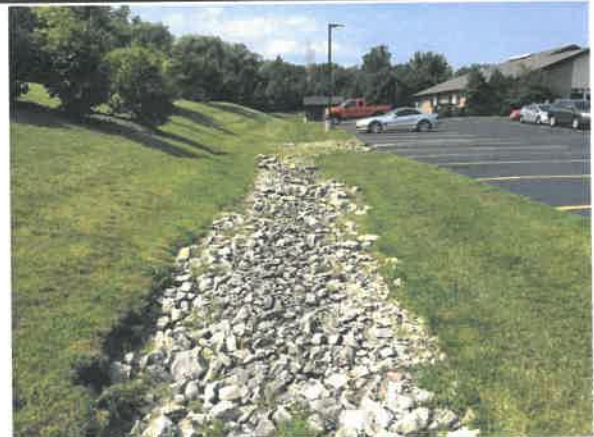
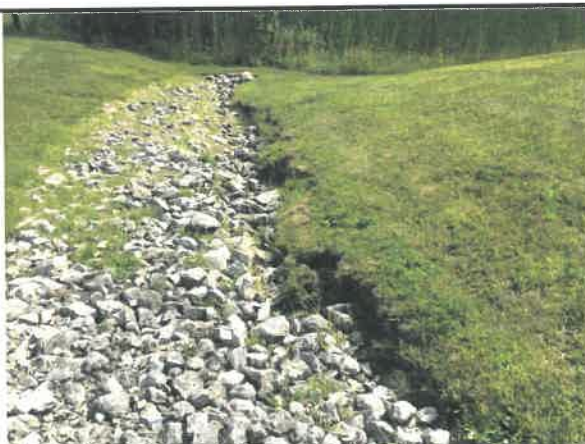
Additional comments:
Side of trench eroding away

Side of trench eroding away

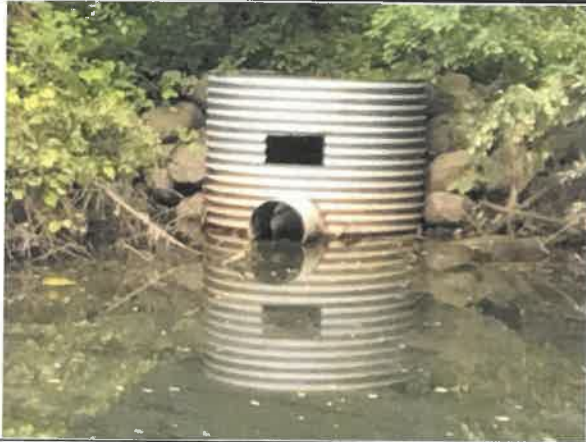
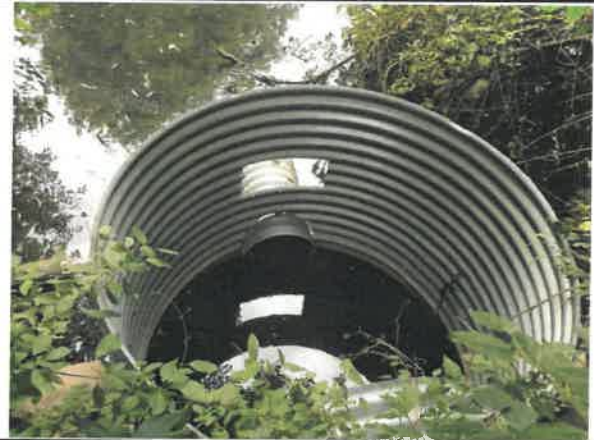
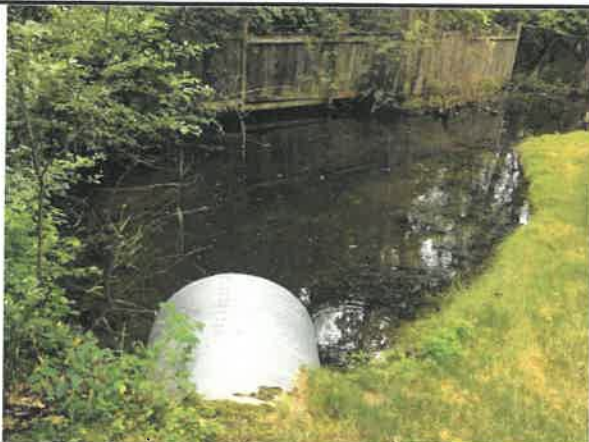
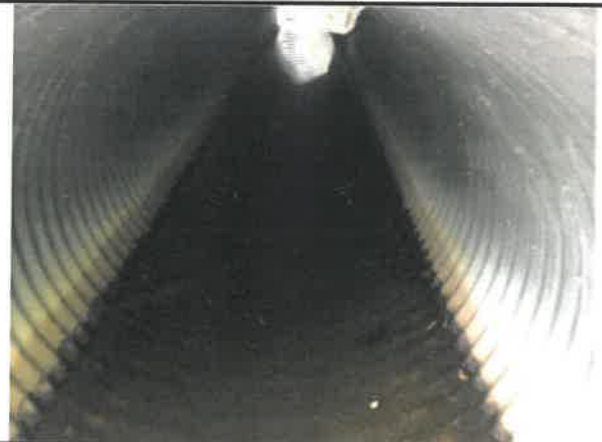
Additional comments:
Heavy vegetation surrounding outfall

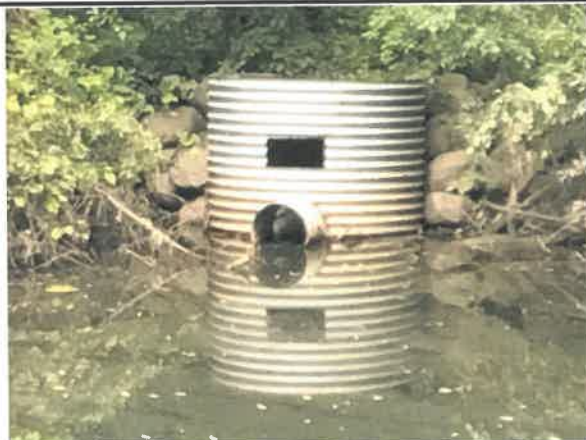
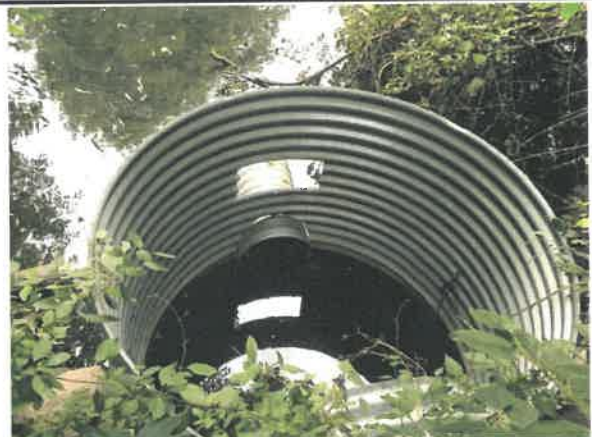
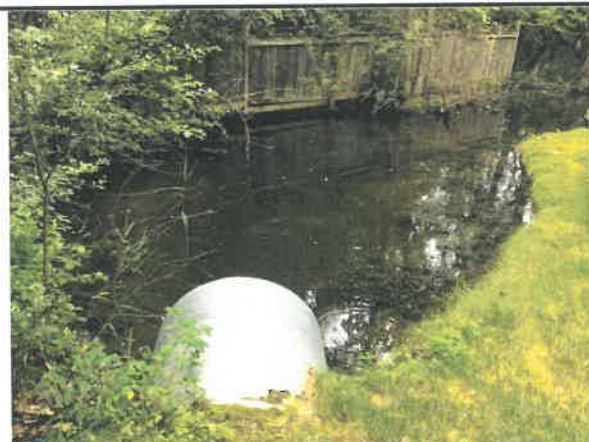
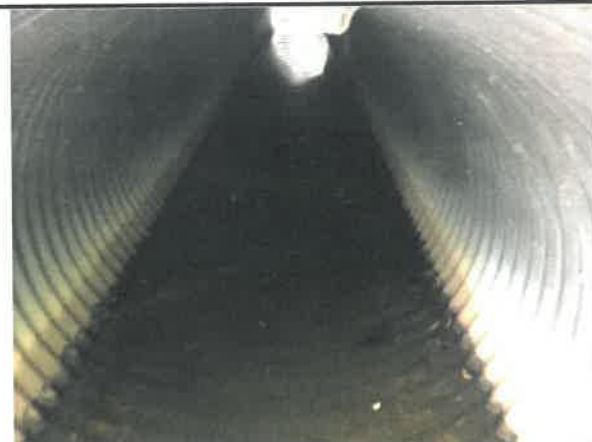
Community: Libertyville		Outfall ID: 15	Date/Time: 07-26-2019 09:15 AM (-5 GMT)	
Land Use: Residential	Prev. 48 Hour Precipitation: 0.00 in.	Temp: 75 F	Inspector Name: Max Goodman

Additional comments:
Heavy vegetation surrounding outfall

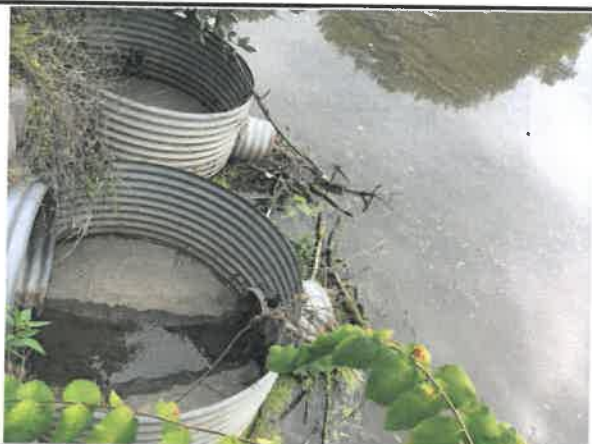
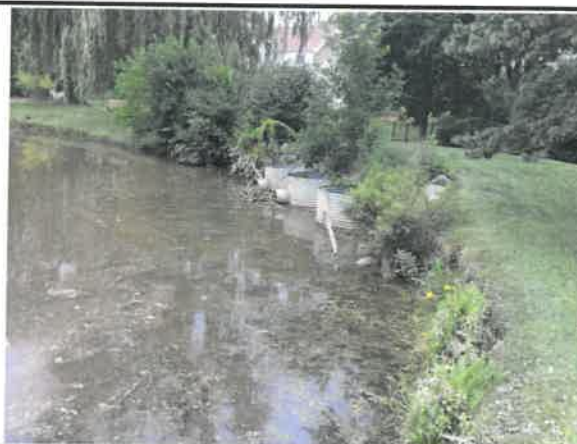
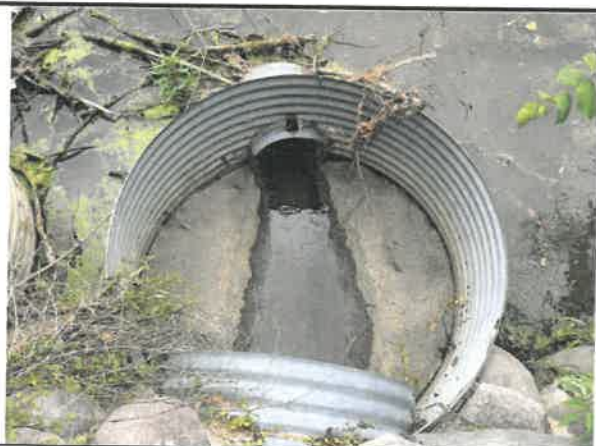
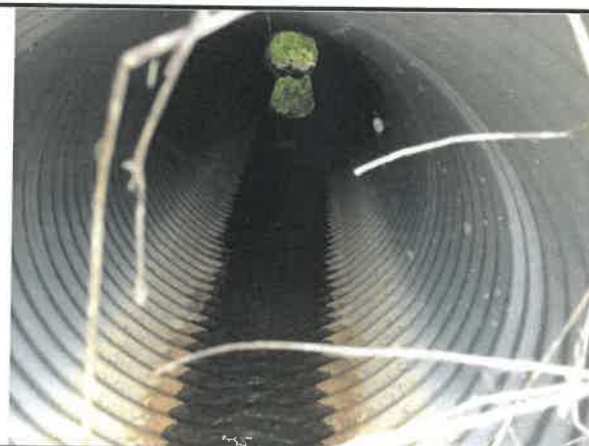
Community: Libertyville		Outfall ID: 16	Date/Time: 07-26-2019 09:00 AM (-5 GMT)	
Land Use: Residential	Prev. 48 Hour Precipitation: 0.00 in.	Temp: 74 F	Inspector Name: Max Goodman

Trickle observed at northerly most inlet, debris obstructing entrance of all inlets

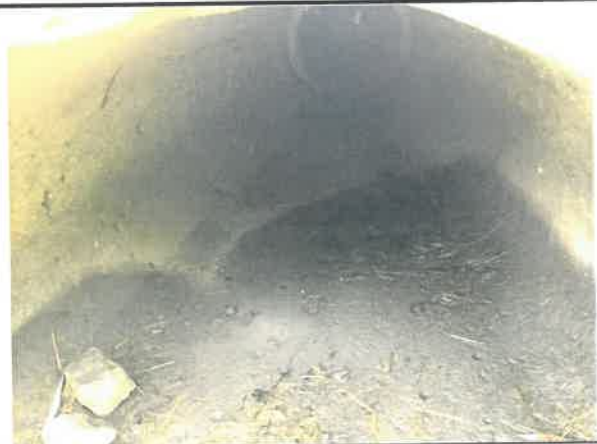
Community: Libertyville		Outfall ID: 17	Date/Time: 07-26-2019 10:50 AM (-5 GMT)	
Land Use: Residential	Prev. 48 Hour Precipitation: 0.00 in.	Temp: 75 F	Inspector Name: Max Goodman

Additional comments:
Missing metal trash grate

View looking into FES

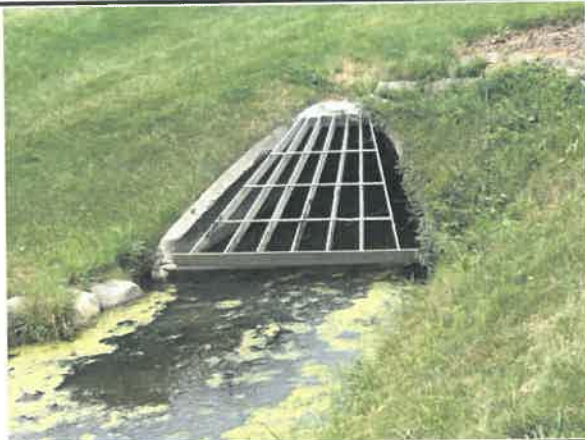
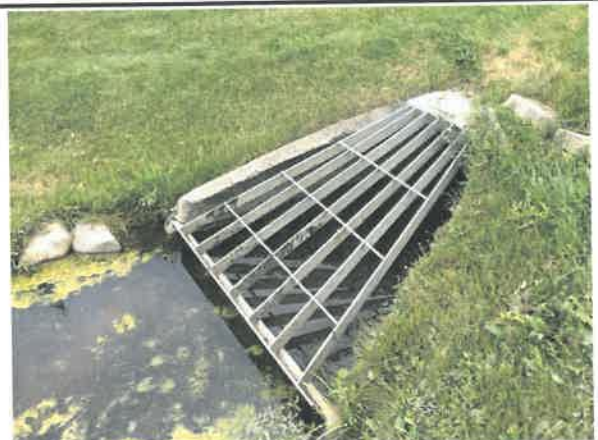
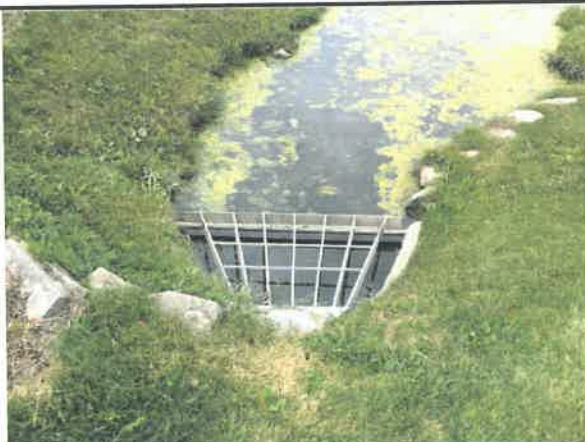
Heavy algae surrounding outfall at opening, submerged in approximately 6-inches of water

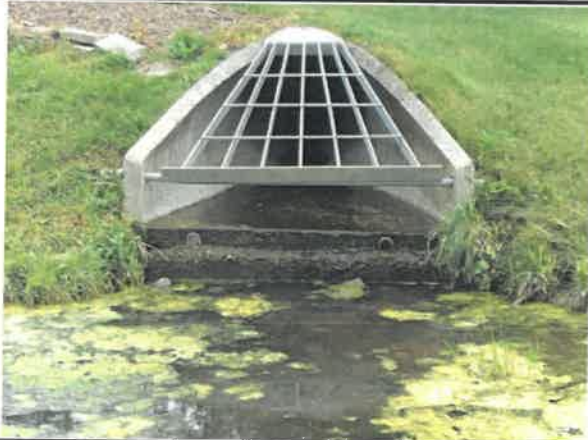
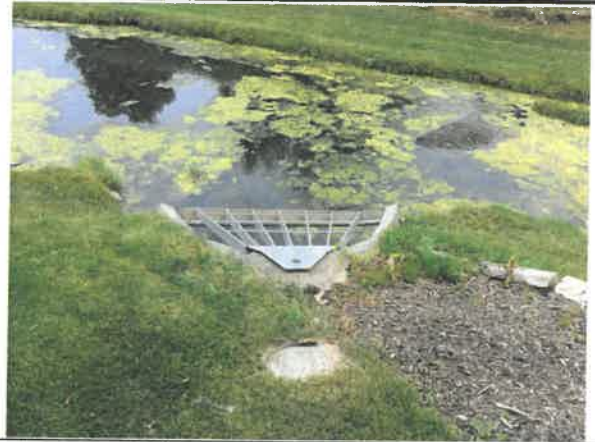
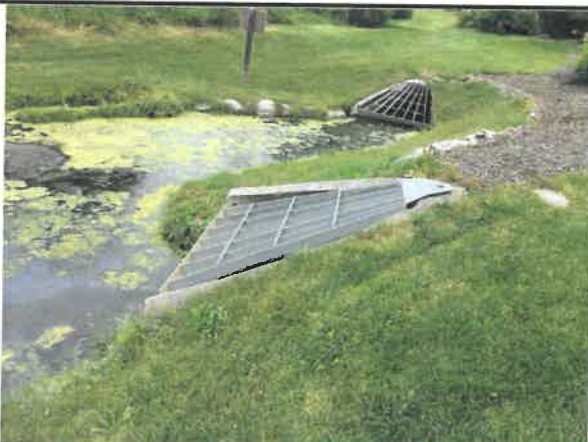
Community: Libertyville		Outfall ID: 20	Date/Time: 07-26-2019 11:15 AM (-5 GMT)	
Land Use: Residential	Prev. 48 Hour Precipitation: 0.00 in.	Temp: 79 F	Inspector Name: Max Goodman

Additional comments:
Minor algae growth in outfall structure

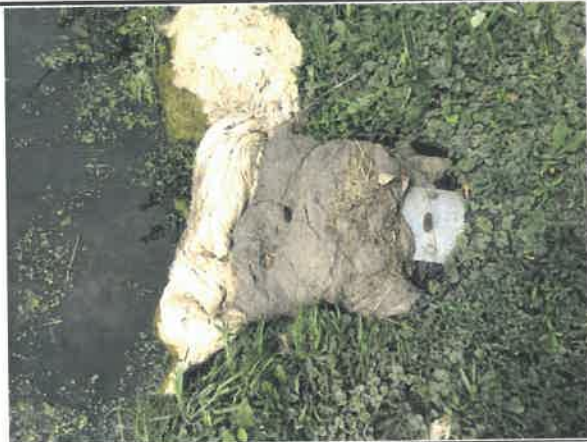
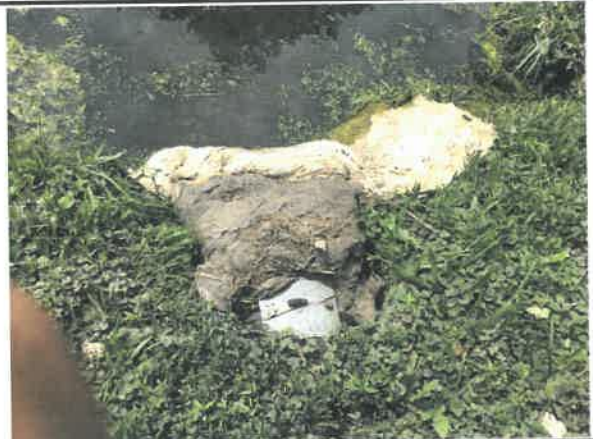
Community: Libertyville		Outfall ID: 21	Date/Time: 07-26-2019 11:15 AM (-5 GMT)	
Land Use: Residential	Prev. 48 Hour Precipitation: 0.00 in.	Temp: 75 F	Inspector Name: Max Goodman

*Revised per ATL revision: outfall is not submerged, it is covered with debris.

Completely sedimented due to wildlife

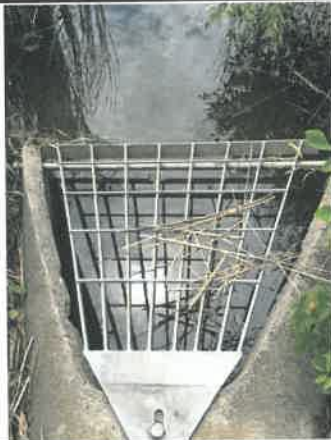
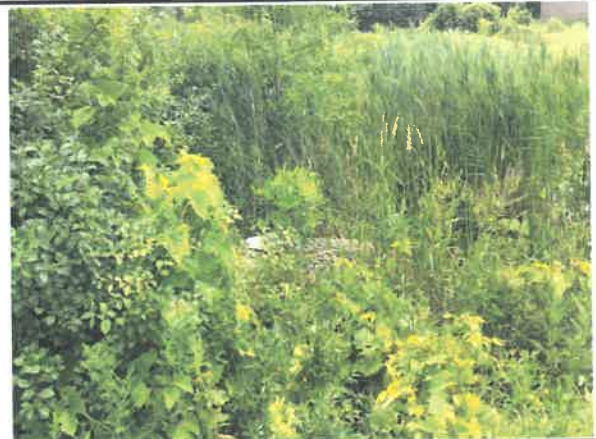
Community: Libertyville		Outfall ID: 23	Date/Time: 07-26-2019 12:15 PM (-5 GMT)	
Land Use: Residential	Prev. 48 Hour Precipitation: 0.00 in.	Temp: 85 F	Inspector Name: Max Goodman

Additional comments:
Submerged in approximately 13-inches of water

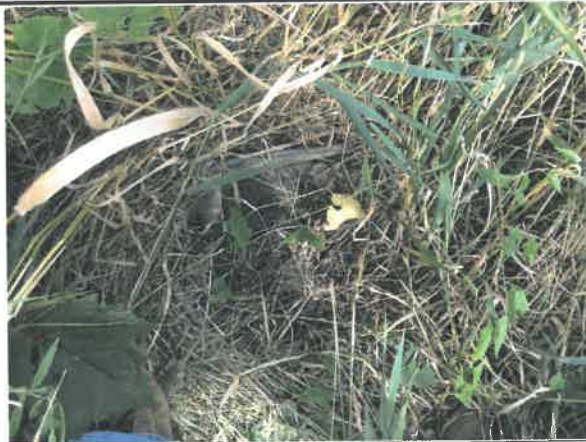
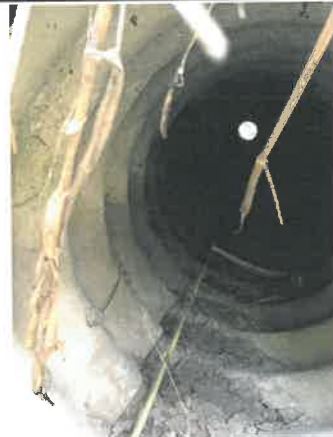
Community: Libertyville		Outfall ID: 32	Date/Time: 07-26-2019 03:00 PM (-5 GMT)	
Land Use: Residential	Prev. 48 Hour Precipitation: 0.00 in.	Temp: 86 F	Inspector Name: Max Goodman

Additional comments:
Completely submerged in sediment

Outfall structure fully submerged in sediment

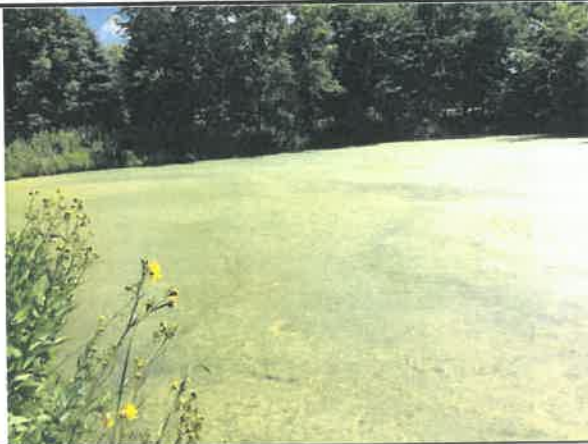
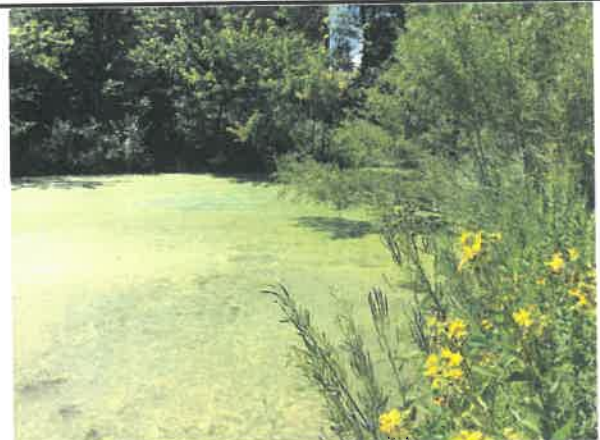
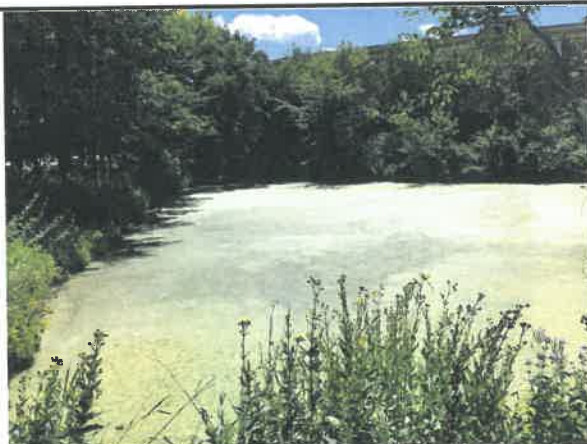
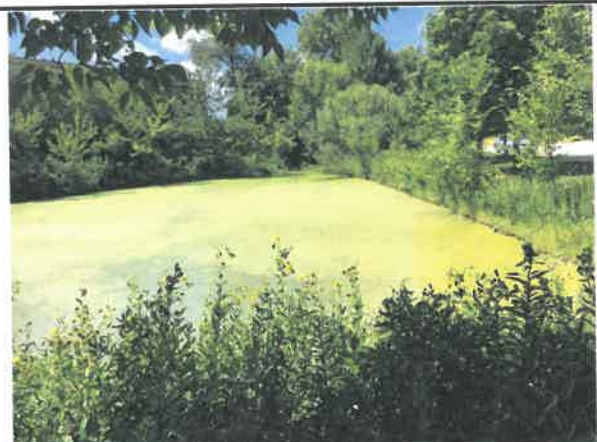
Property Address: Cater		Basin ID: E	Date/Time: 08-08-2019 11:30 AM (-5 GMT)
Land Use: Residential	Weather Conditions: Sunny	Temp: 82 F	Inspector Name: Max Goodman

Additional comments:
Algae coverage of 100% of water surface

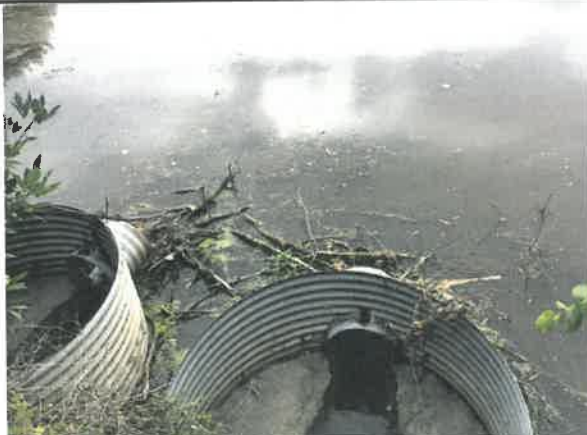
Accumulated debris located at outfall inlet structure, pool clarity poor, no vegetation observed substantial sediment observed

Accumulated debris at outfall structure

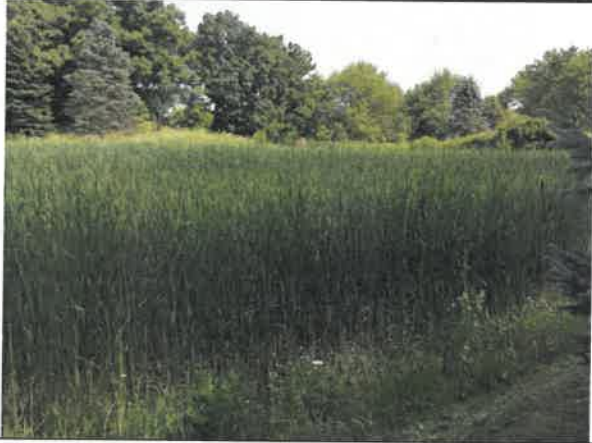
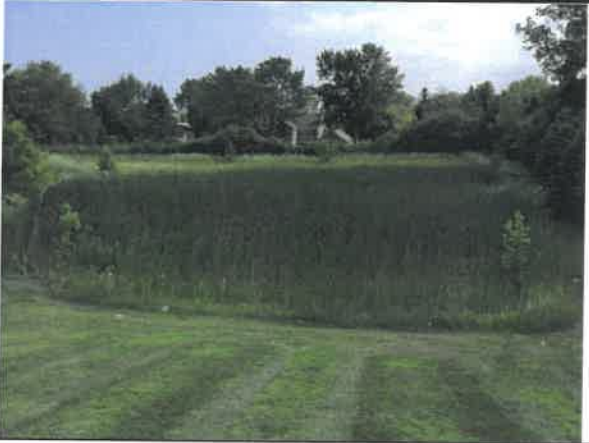
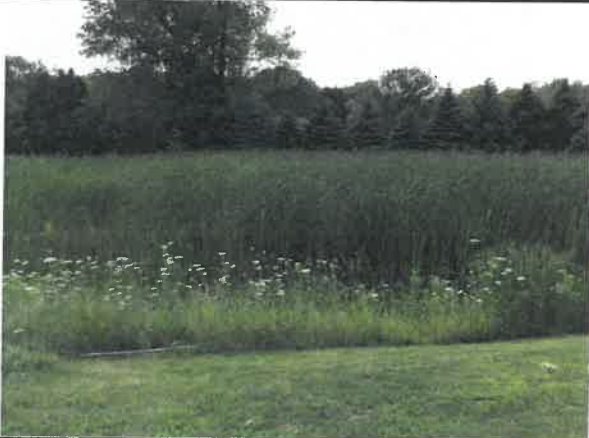
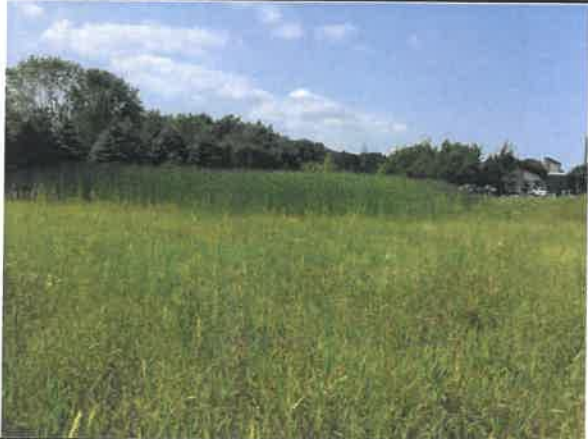
Additional comments:
Cattail vegetation covering entire basin

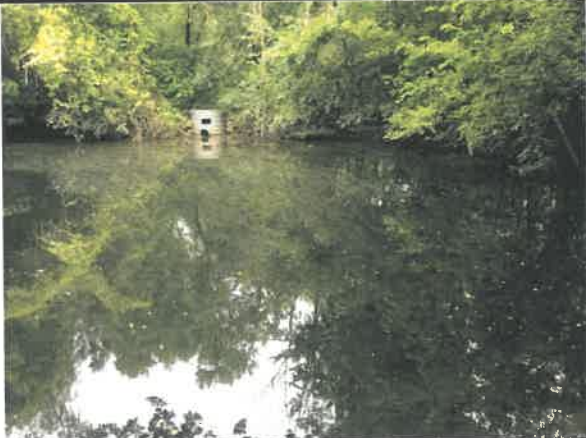
Additional comments:
Sheen on surface of water throughout basin

Sheen on surface of water	Northeastern side of basin looking south

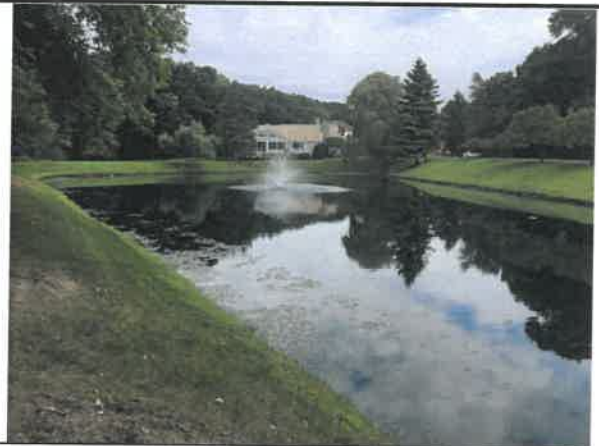
Southwesterly side of basin looking north easterly

Heavy debris on southerly side of basin, clean out maintenance recommended

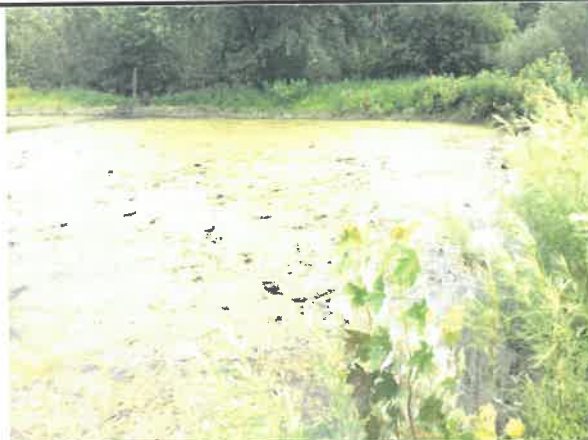
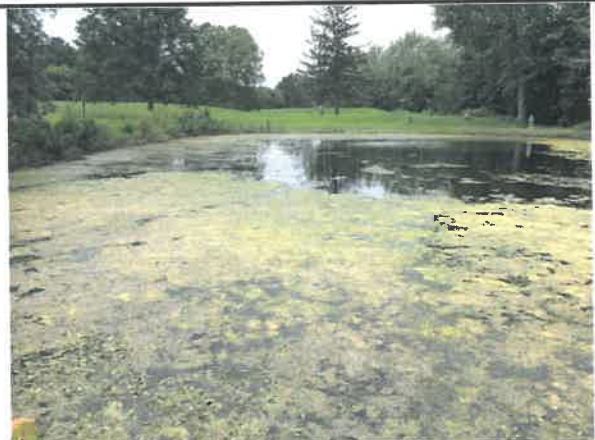
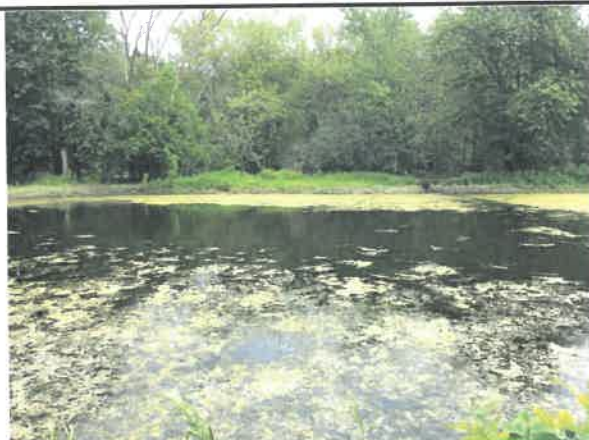
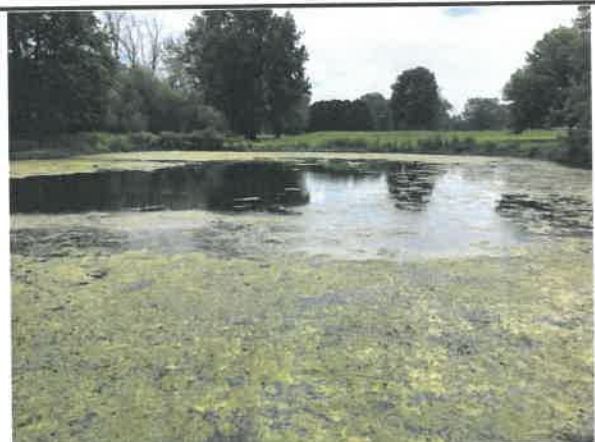
Additional comments:
Algae growth covering approximately 60% of water surface

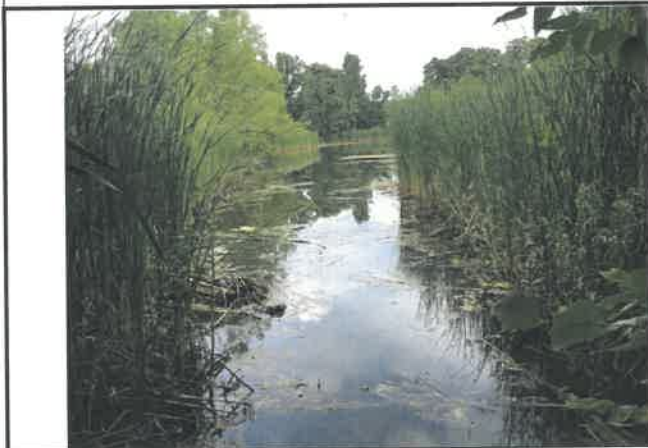
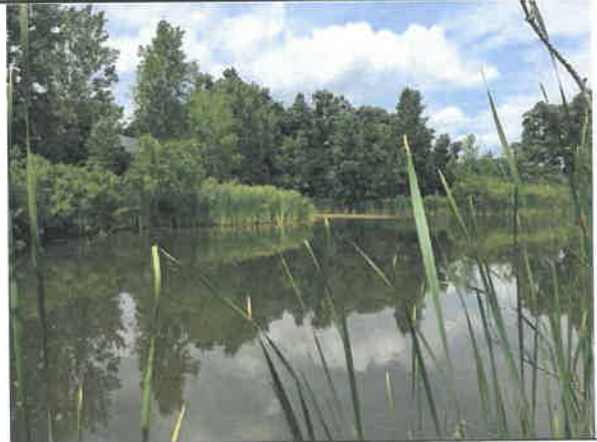
Additional comments:
Cattails surrounding perimeter of basin

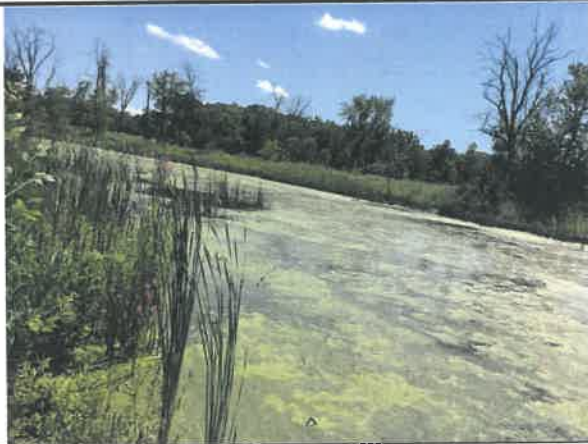
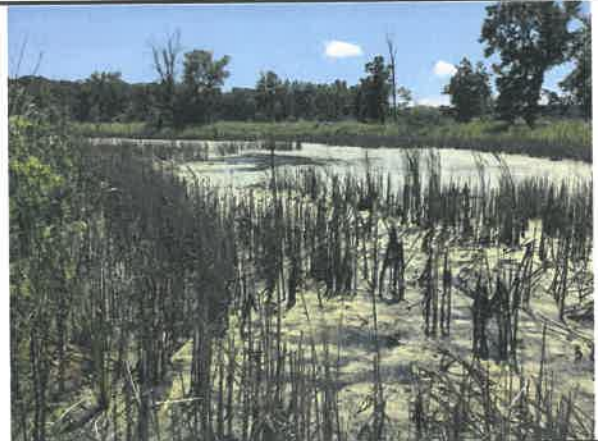
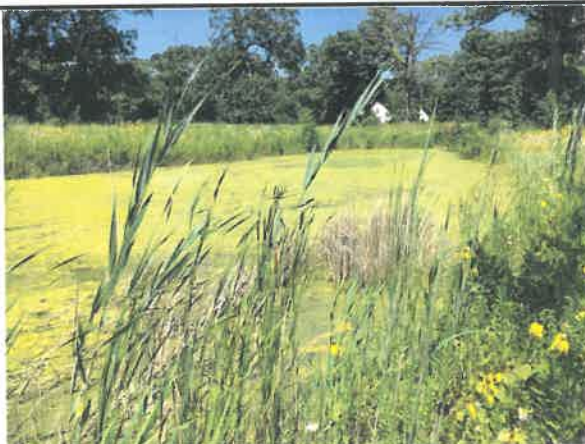
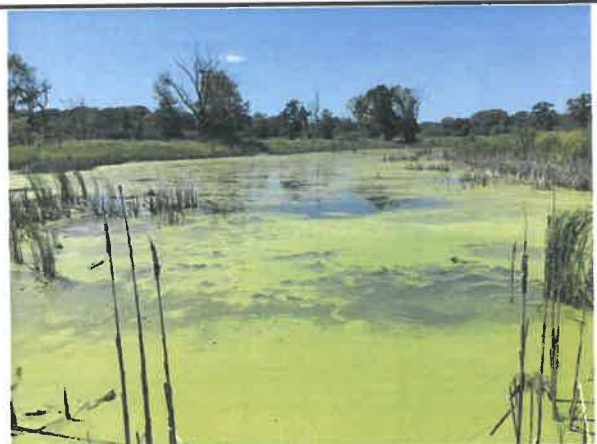
Additional comments:
Green algae coverage, heavily vegetated area

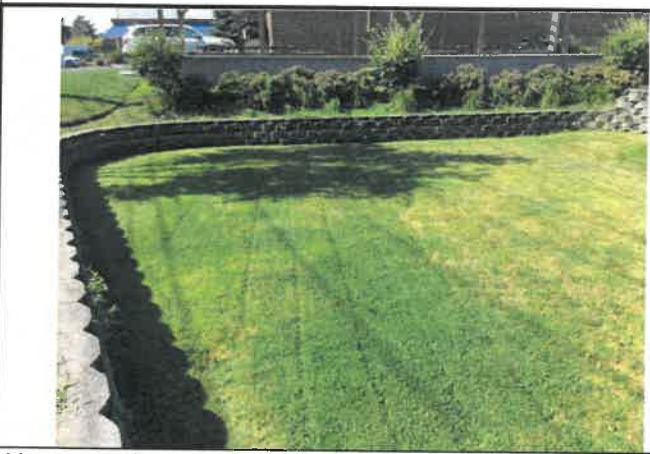
Northerly Side of basin looking south

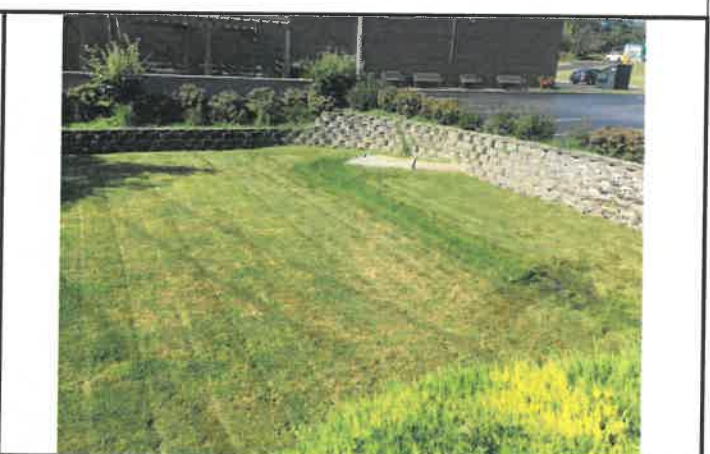
Northwesterly side of basin looking southeast

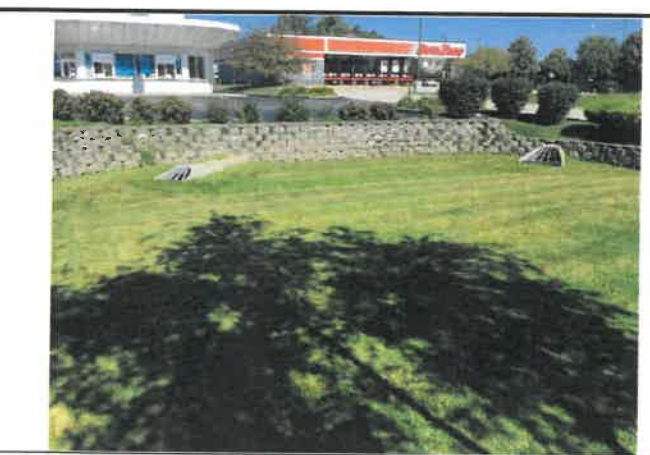
Southeasterly side of basin looking northwesterly

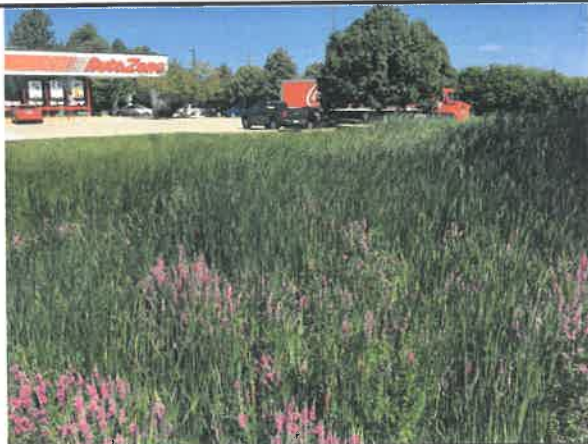
Additional comments:
Excessive quality of cattail vegetation

Southeasterly side of basin looking northwesterly

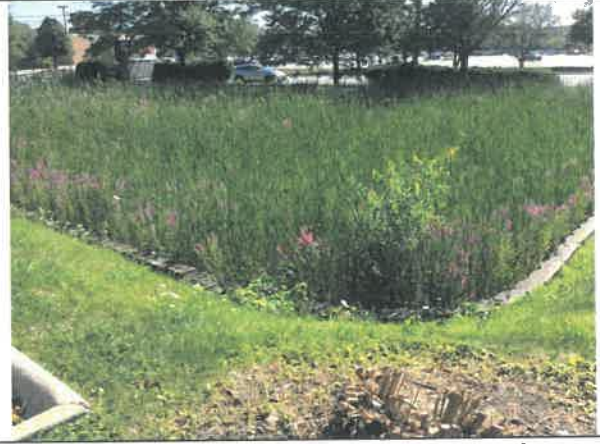
Southwesterly side of basin looking northeasterly

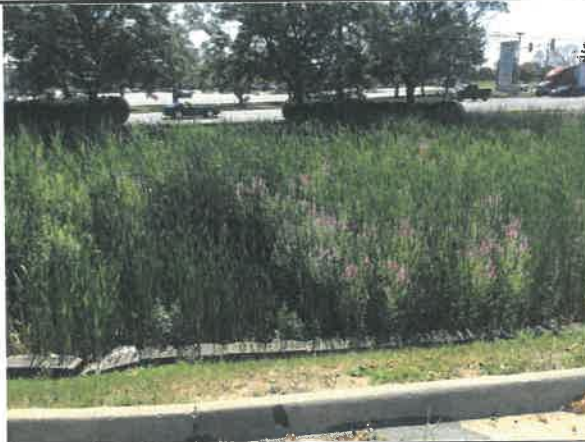
Westerly side of basin looking easterly

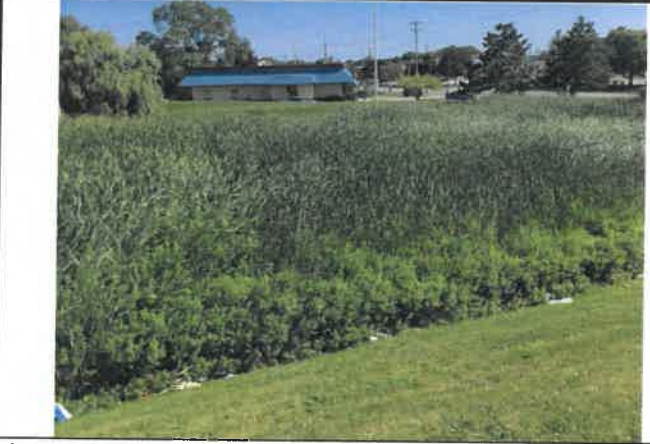
Additional comments:
Excessive quality of cattail vegetation

Southerly side of basin looking northerly

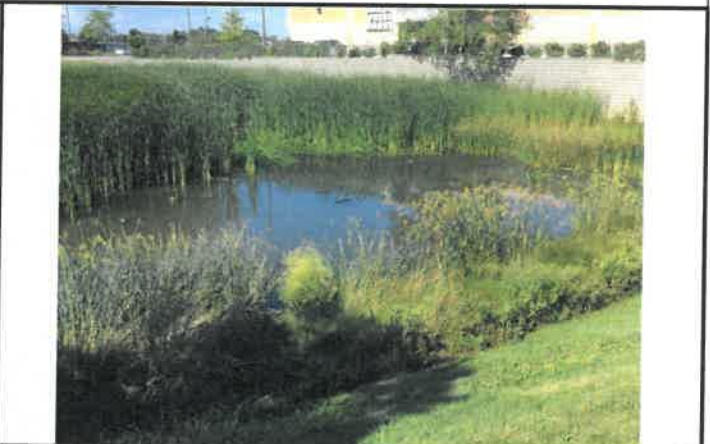
Northerly Side of basin looking southwest

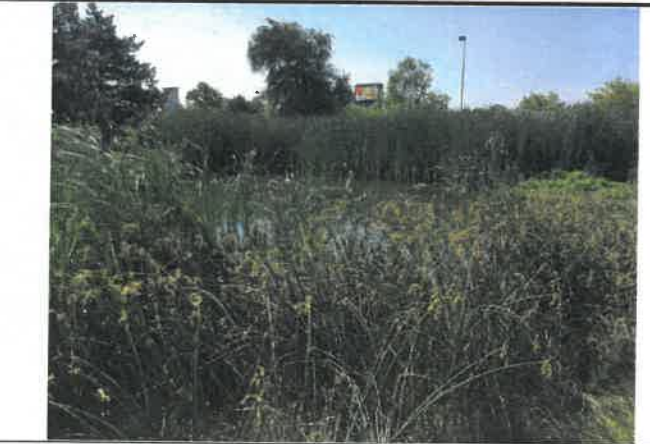
Westerly side of basin looking easterly

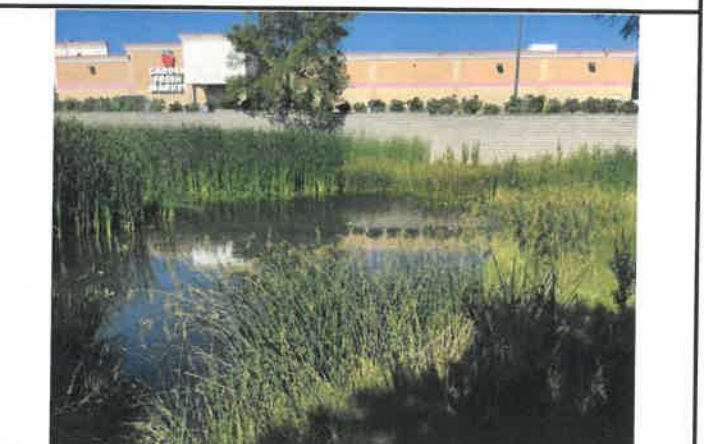
Easterly side of basin looking west

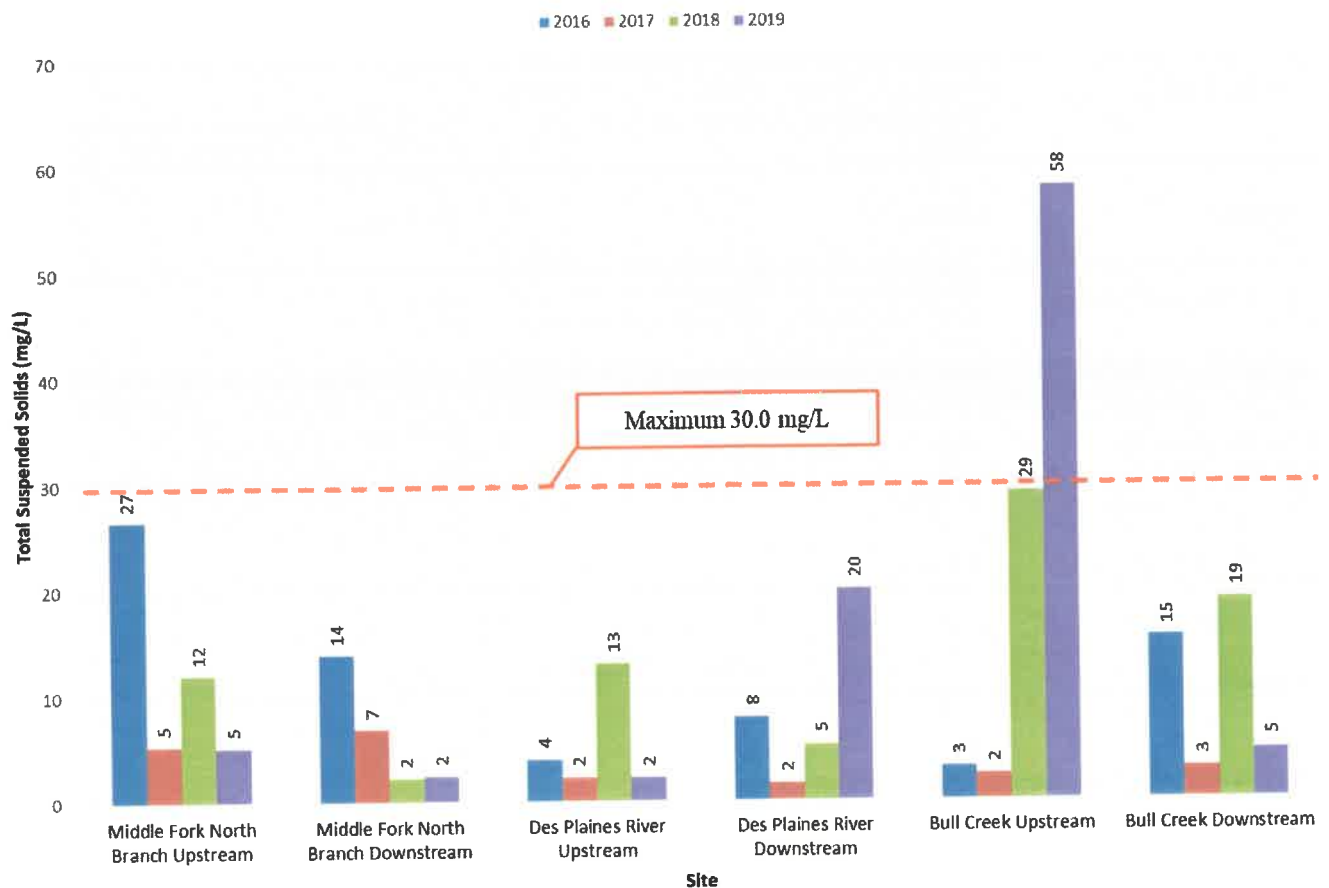
Total Suspended Solids (mg/L)

The established limit for TSS is 15.0 – 30.0 mg/L (effluent limit under Part 304 Effluent Standards). Results of the TSS testing conducted from 2016 through 2019 are provided in the graph below. In 2019, the Bull Creek Upstream exceeded the 30 mg/L threshold.

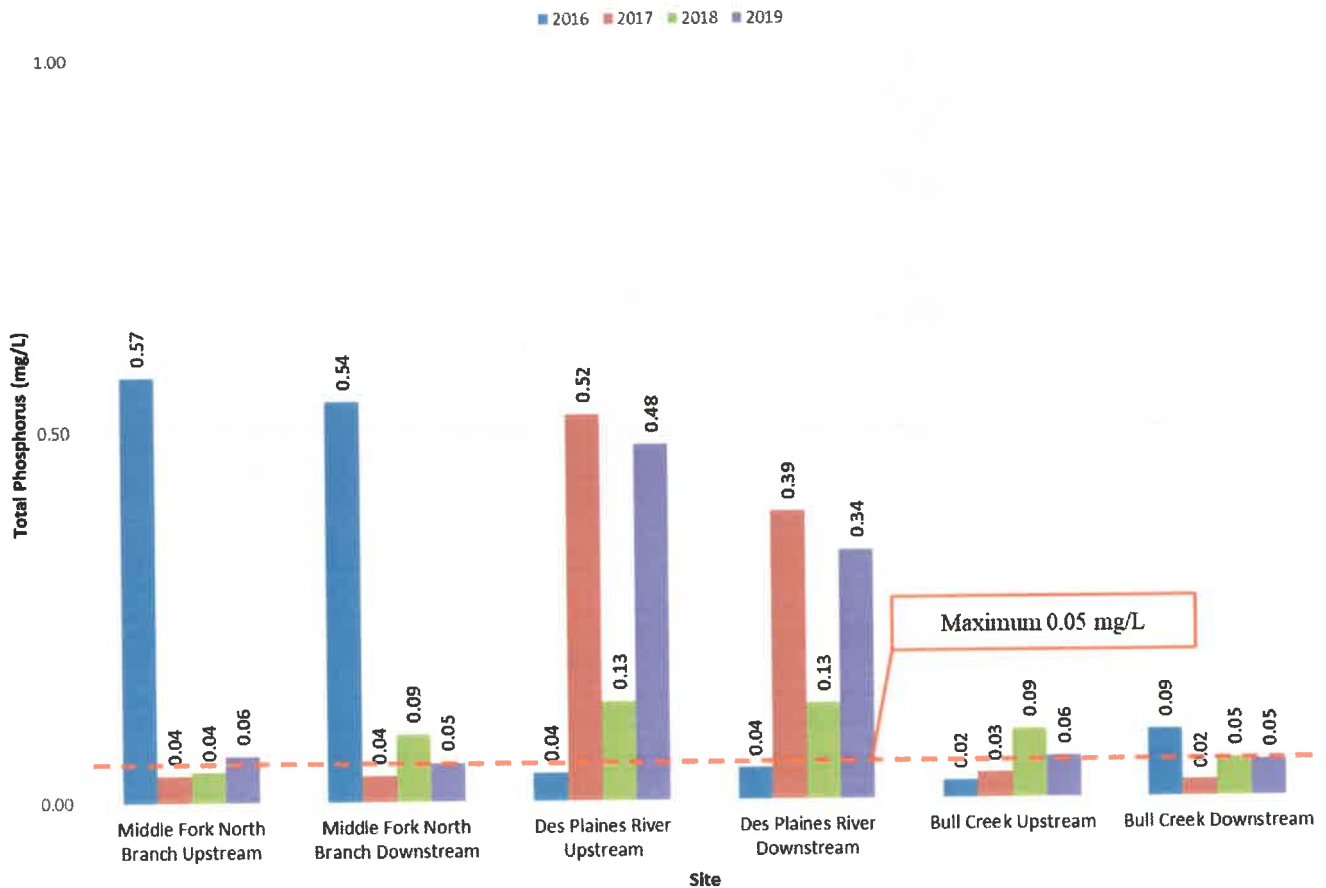
Total Phosphorus (mg/L)

The established limit for total phosphorous is 0.05 mg/L for any reservoir or lake with a surface area of ≥ 20.0 acres, or in any stream at the point where it enters any such reservoir or lake. Results of the phosphorus testing conducted from 2016 through 2019 are provided in the graph below. The majority of test results since 2016 have exceeded the 0.05 mg/L threshold. However, it should be noted that this threshold is used as a guideline only as it is applicable to reservoirs and lakes. In 2019, five (5) locations exceeded the 0.05 mg/L threshold, though it should be noted that levels decreased from the upstream sampling levels.

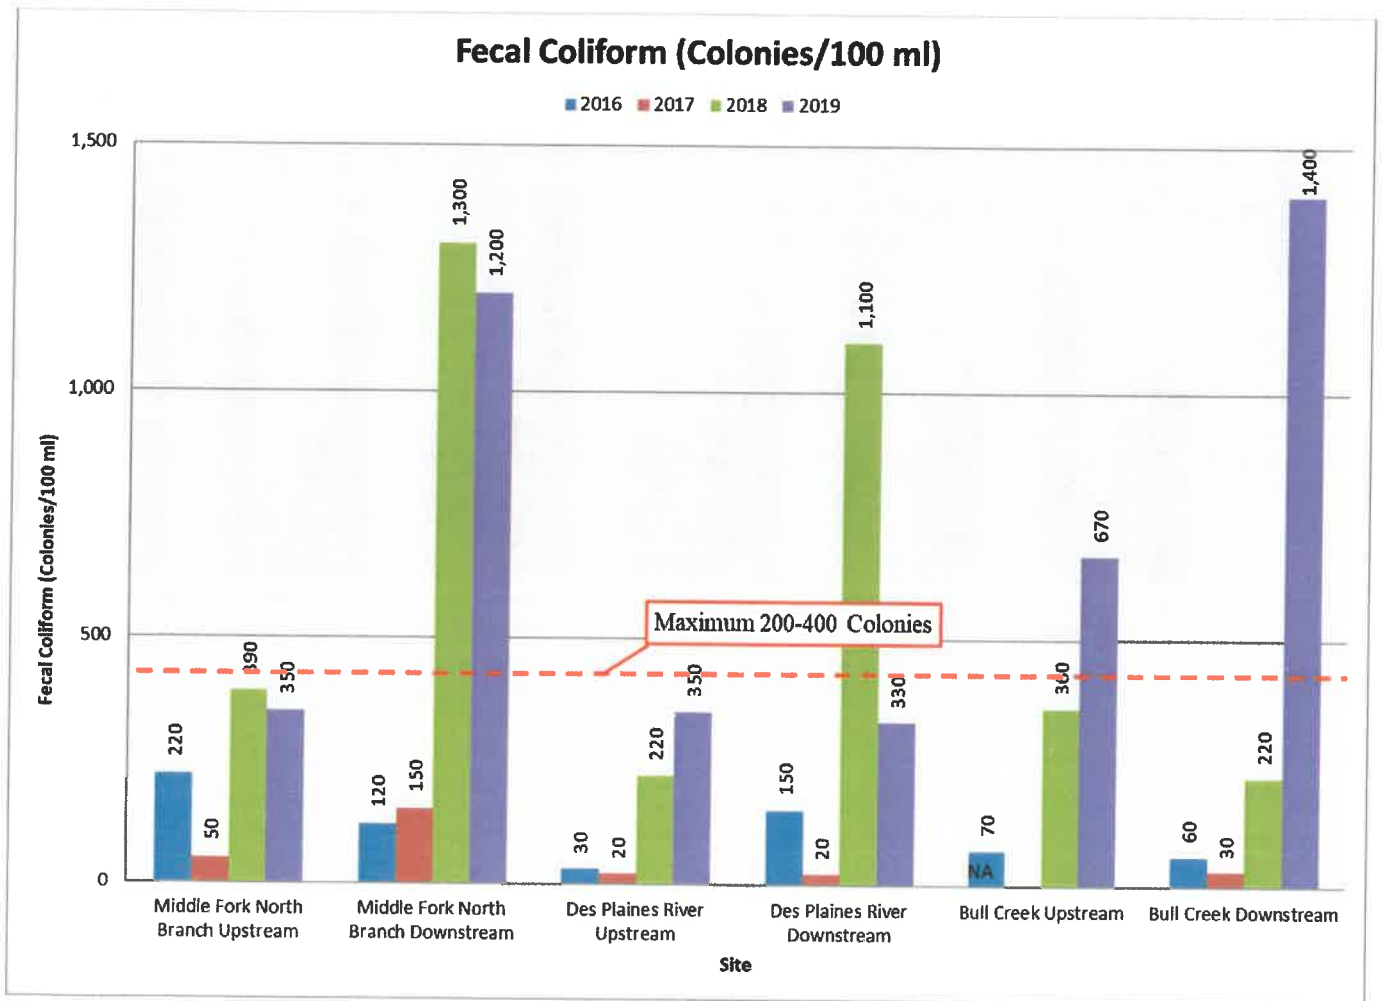
The Des Plaines River and the Middle Fork North Branch Chicago River are impaired for fecal coliform. Fecal coliform testing began in 2016 to meet the monitoring requirements of the 2016 NPDES ILR40 permit. Results of the fecal coliform testing conducted in 2019 are provided in the graph below. In 2019, three (3) of the sites exceeded the 400 cfu threshold. While no additional sampling and testing is recommended at this time, the Township should *consider* adding additional sampling for 2020. It is recommended that the results be shared with surrounding MS4s, particularly the Villages of Libertyville, Mundelein, and Green Oaks.

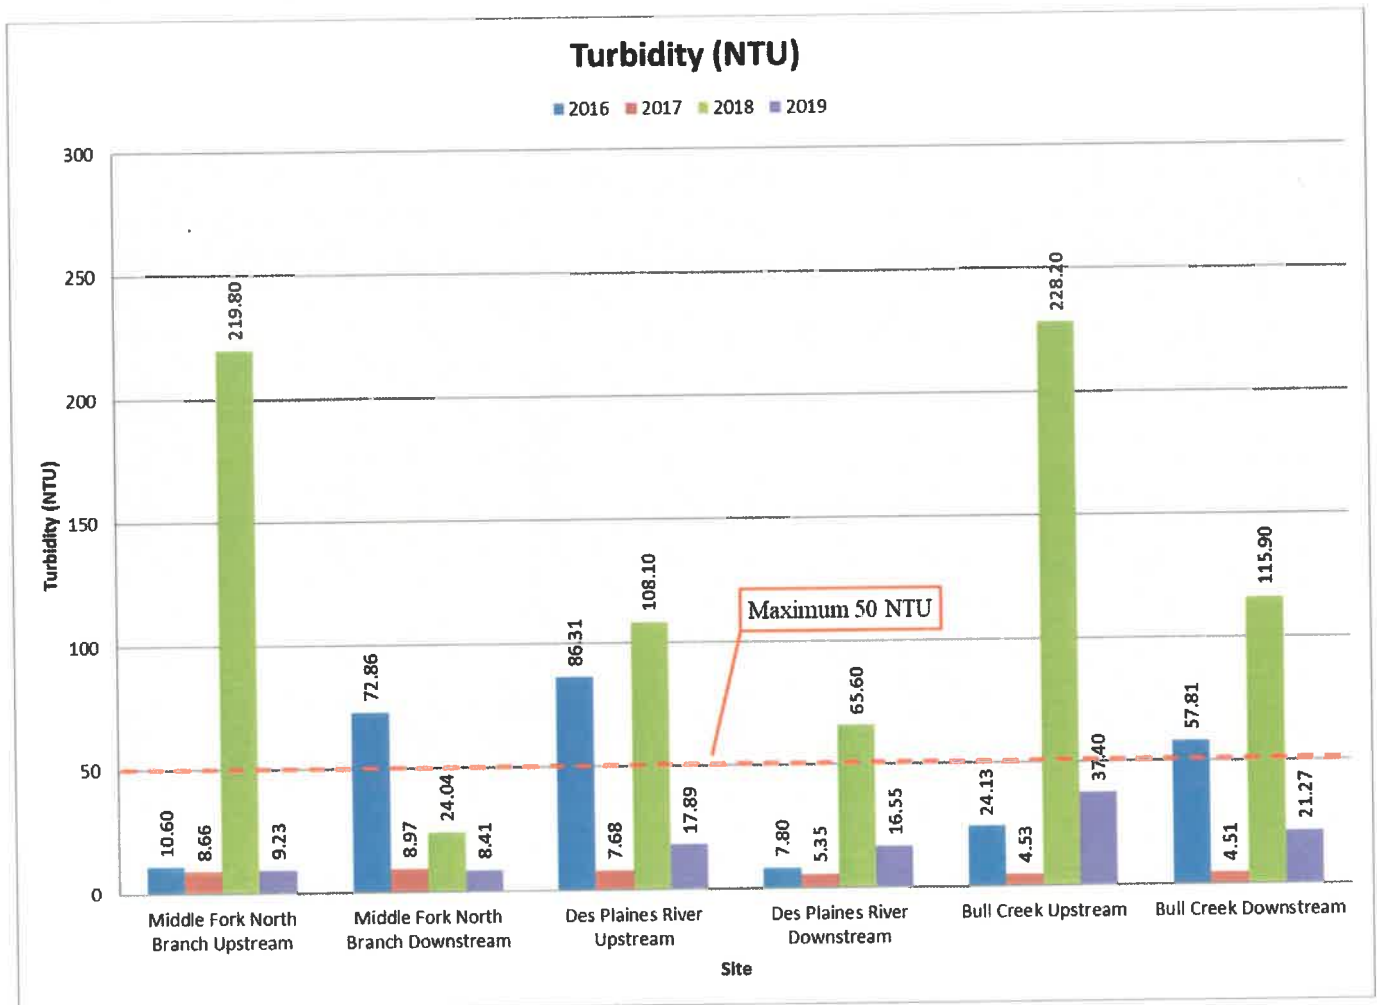
While there is no water quality standard in Illinois for turbidity, other states have ambient water quality standards ranging from 10 NTU to 50 NTU, depending on the water body. Therefore, a value of 50 NTU is established for turbidity in this analysis. Turbidity testing began in 2016 to meet the monitoring requirements of the 2016 NPDES ILR40 permit. Results of the turbidity testing conducted in 2019 are provided in the graph below. In 2019, none of the locations exceeded the 50 NTU threshold.
