2019 Outfall and Basin Inspection Report

Libertyville Township
Lake County, IL
December 2019

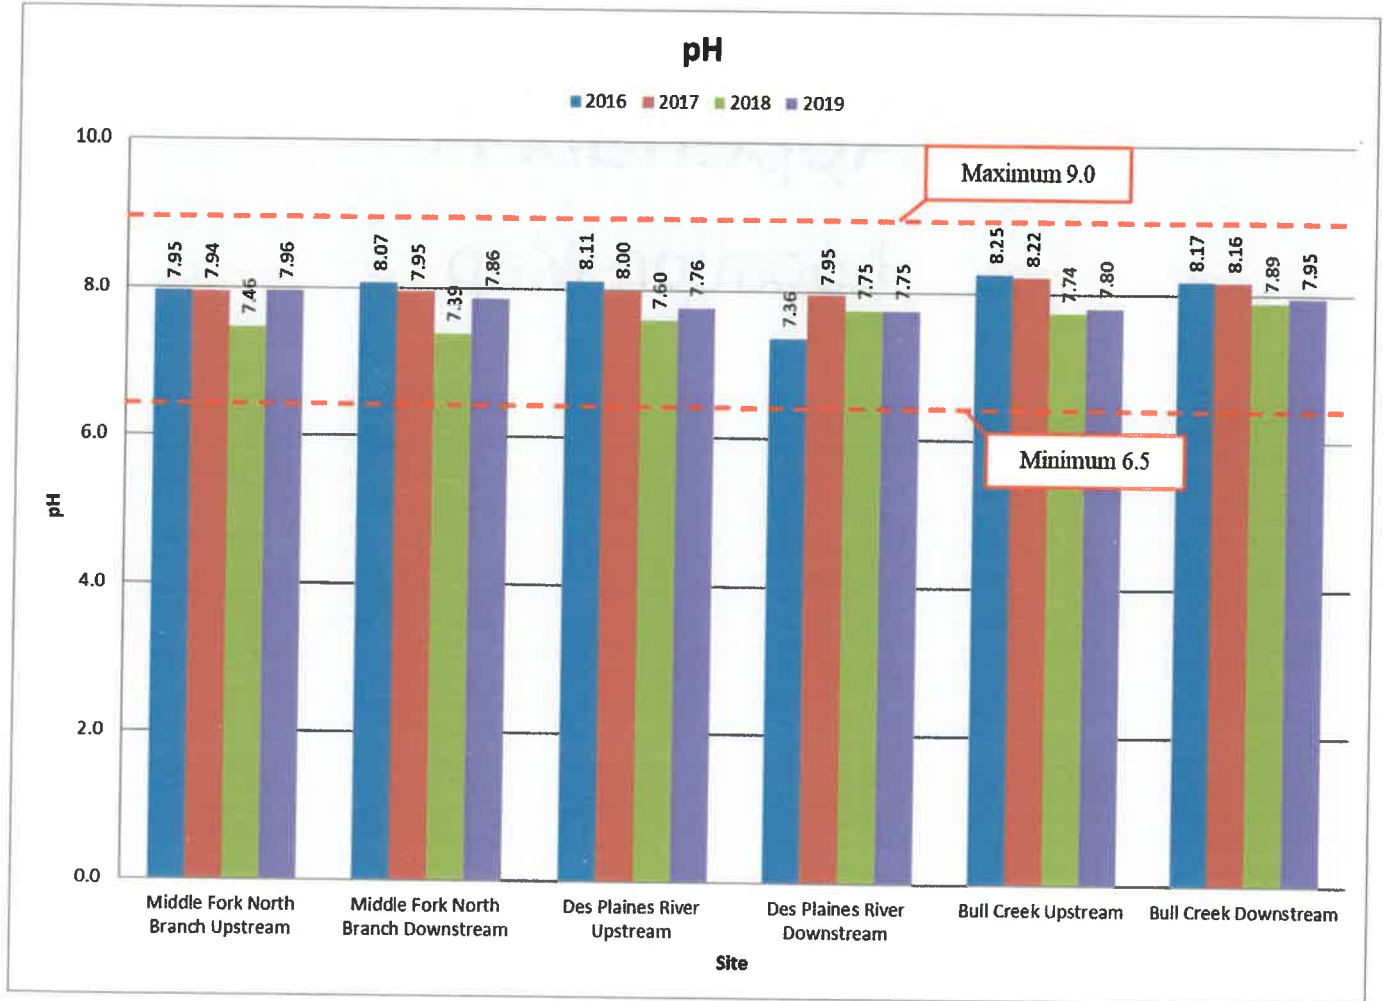
The established range for pH is 6.5-9.0 (General Use WQS). pH readings from 2016 through 2019 are provided in the graph below. All results have been within the established range.
